Property Inspection Report

12345 Oak, St Clair Shores, MI 48081 Inspection prepared for: Frank Starkey & Sally Starkey Real Estate Agent: Mary Test - Upper Clair Realty

Date of Inspection: 8/15/2012 Time: 11:45am Age of Home: 55 Size: 1400 Weather: sunny warm 85 degrees

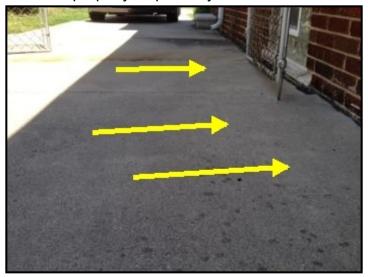
• The driveway is improperly sloped towards the foundation. Water can infiltrate into the interior. Recommend repairing (pump jacking)or replacing the drive to properly slope away from the foundation.

drive pitching wrong way toward house - possible water intrusion if left unrepaired

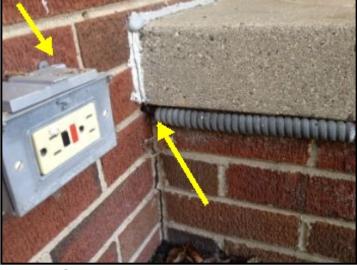
Broken GFI cover / exposed wires routed through brick wall

- Missing cover on outside front porch GFI box
- Conduit seperation at both front porch and rear patio electric feeds. Exposed wires. Recommend further evaluation by a licensed electrician.

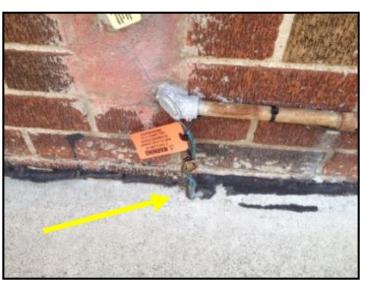
ground wire run through the cement driveway unsleeved

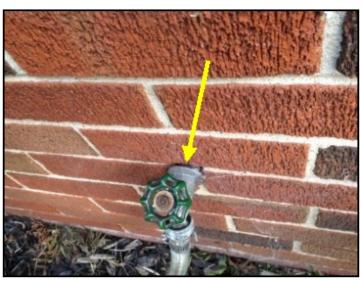
caulk needed at faucet to prevent water intrusion

• Appears Functional. Caulk where spigot meets the house wall to prevent moisture intrusion - recommend handyman services

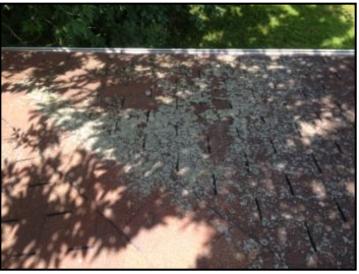
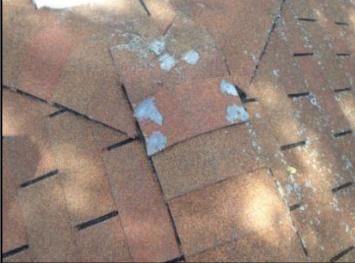
Exposed nails on roofing material. Recommend sealing all fastener heads.

Garage roof beyond it's intended service life- OK exposed nails in garage ridge cap shingle- seal to prevent water intrusion

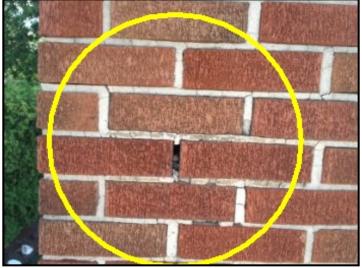
- No major system safety or function concerns noted at time of inspection.
 Chimney Mortar shows sign of deterioration. Recommend having repaired as necessary.

minor tuck pointing needed on chimmney

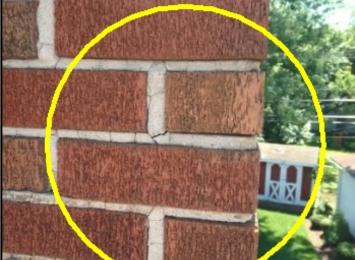
weathered mortor joints - tuck pointing needed

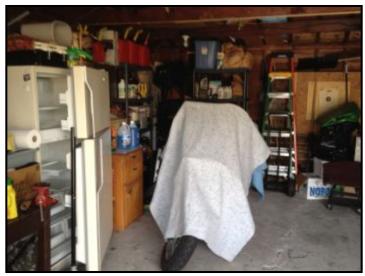
some portions of the garage were not viewable due to item storage

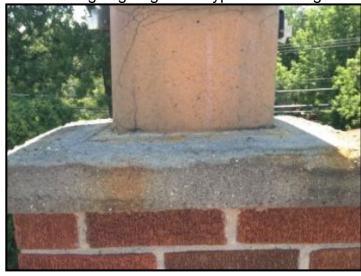
chimmney cap ok . monitor annually
