ACE Home Inspection Service
Property Inspection Report

12345 Oak, St Clair Shores, MI 48081
Inspection prepared for: Frank Starkey & Sally Starkey
Real Estate Agent: Mary Test - Upper Clair Realty

Date of Inspection: 8/15/2012 Time: 11:45am
Age of Home: 55 Size: 1400
Weather: sunny warm
85 degrees

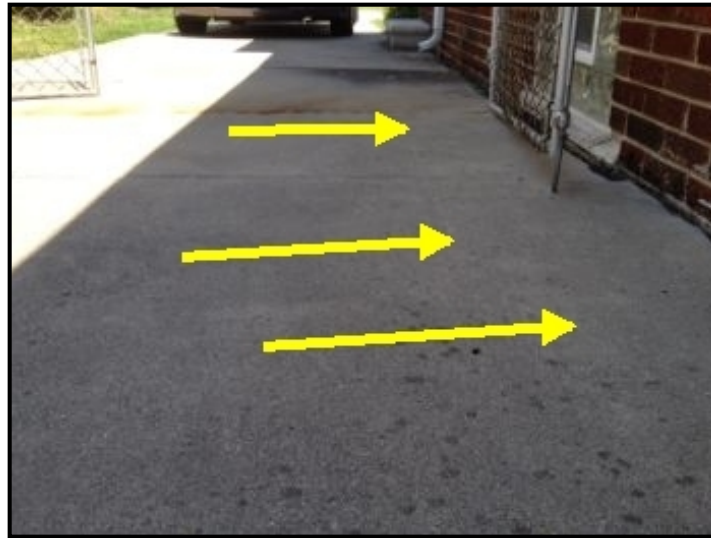
- The driveway is improperly sloped towards the foundation. Water can infiltrate into the interior. Recommend repairing (pump jacking) or replacing the drive to properly slope away from the foundation.

drive pitching wrong way toward house - possible water intrusion if left unrepaired

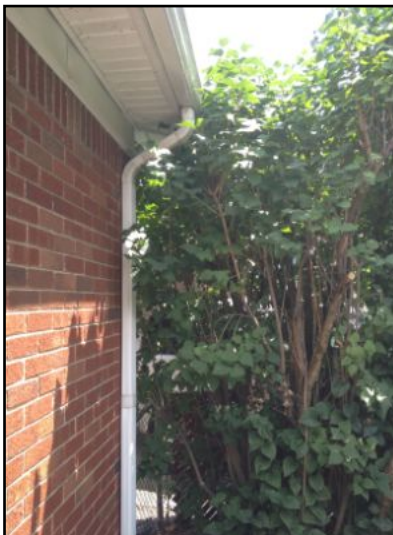
- Trim trees that are in contact or proximity to home, as branches can abrade roofing or siding.

trim vegetation at least 1 foot from wall

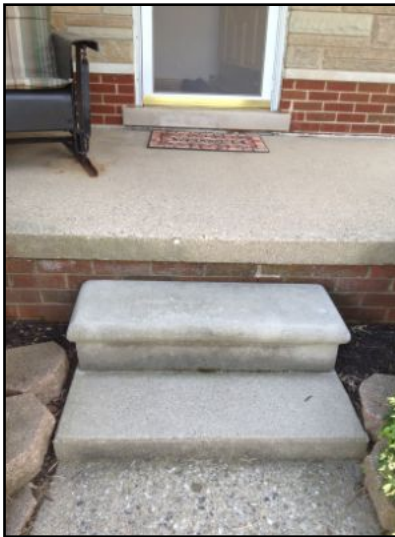
unequal step risers can be a tripping hazard @ front porch/entry

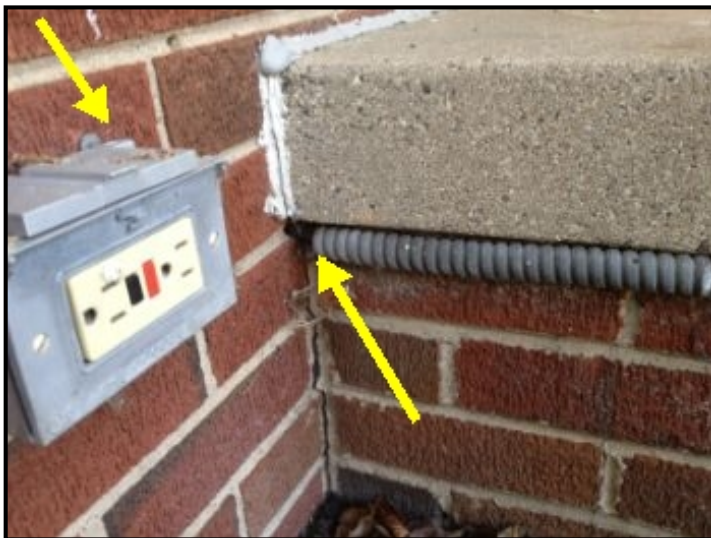
Broken GFI cover / exposed wires routed through brick wall

- Missing cover on outside front porch GFI box
- **Conduit seperation at both front porch and rear patio electric feeds. Exposed wires. Recommend further evaluation by a licensed electrician.**

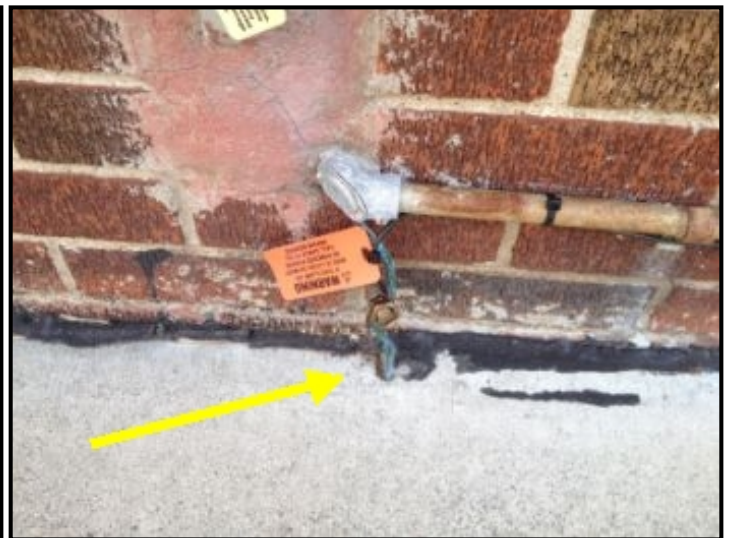
ground wire run through the cement driveway unsleeved

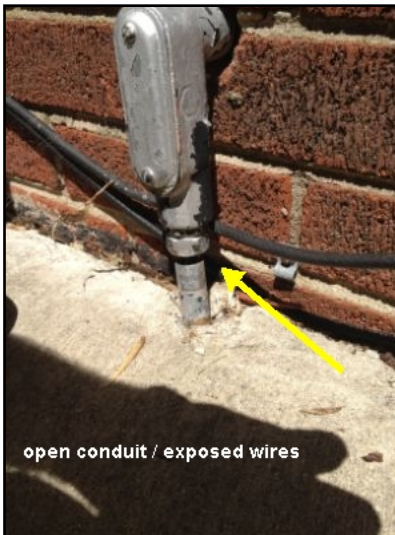
conduit separated- missing sleeve where directed through concrete - back patio- consult licensed electrician

| Grounds | | |
|---|---|--|
| Page 6 Item: 8 | GFCI | • Conduit separation at both front porch and rear patio electric feeds. Exposed wires. Recommend further evaluation by a licensed electrician. |

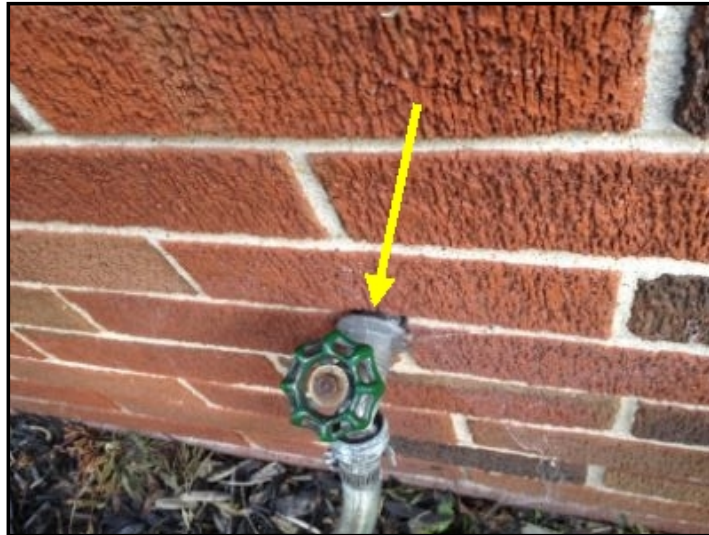
caulk needed at faucet to prevent water intrusion

- Appears Functional. Caulk where spigot meets the house wall to prevent moisture intrusion - recommend handyman services

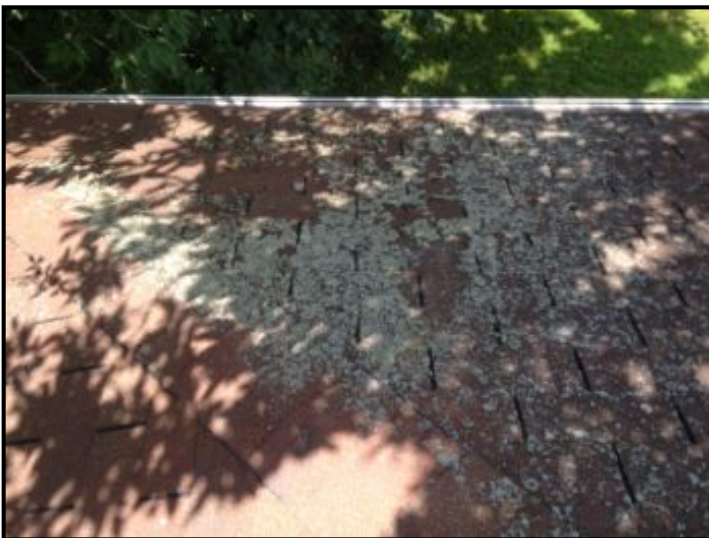
Materials: Roof is beyond its intended service life
 Materials: Asphalt shingles noted.

Garage roof beyond it's intended service life- OK at time of inspection

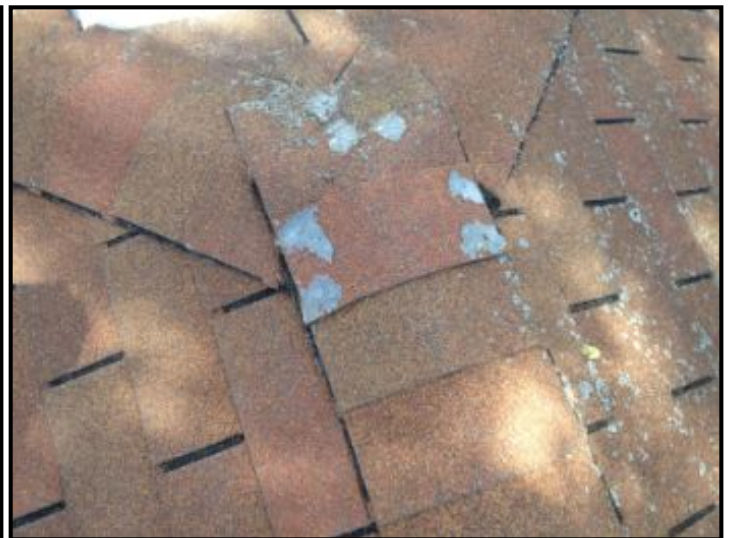
exposed nails in garage ridge cap shingle- seal to prevent water intrusion

- No major system safety or function concerns noted at time of inspection.
- Moss on roof. This can lead to the premature failure of the roof and subsequent leaks. Recommend treating moss during its growing season (wet months) with a moss killer. For information on various moss treatment products and their pros and cons, visit <http://bryophytes.science.oregonstate.edu/page24.htm>.
- Exposed nails on roofing material. Recommend sealing all fastener heads.

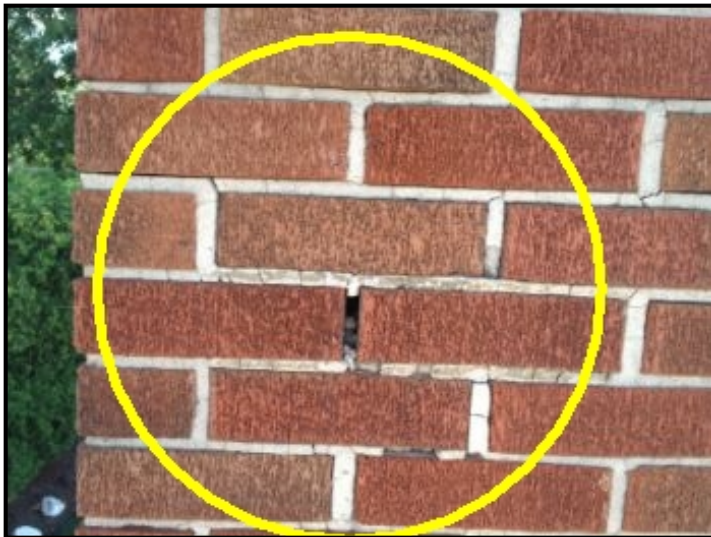
minor tuck pointing needed on chimney

- No major system safety or function concerns noted at time of inspection.
- Chimney Mortar shows sign of deterioration. Recommend having repaired as necessary.

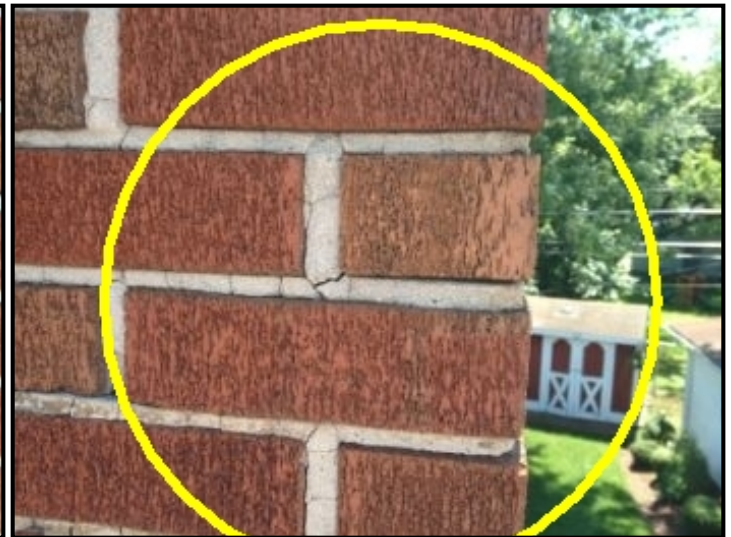
weathered mortar joints - tuck pointing needed

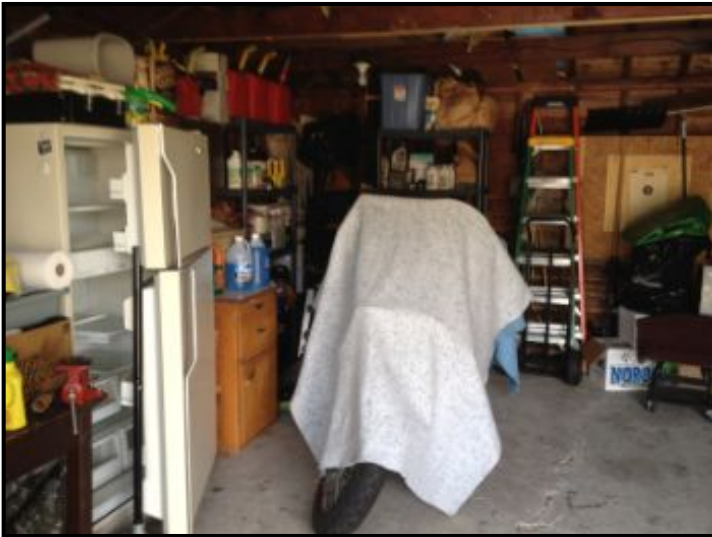
some portions of the garage were not viewable due to item storage

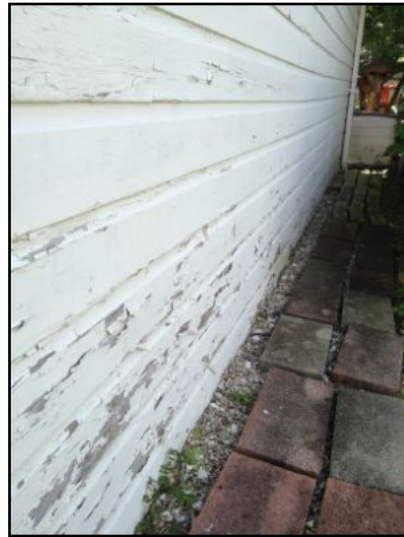
exterior walls of the garage could benefit from a new coat of paint

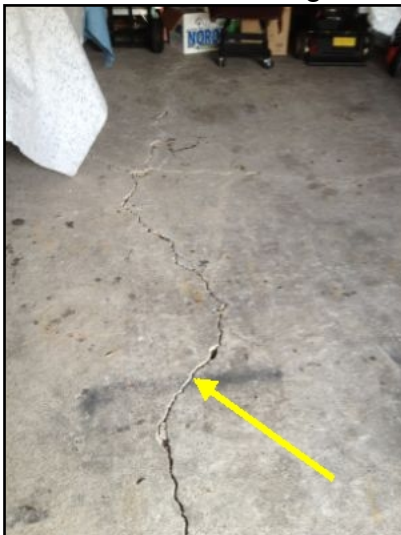
cracking in garage floor typical for it's age

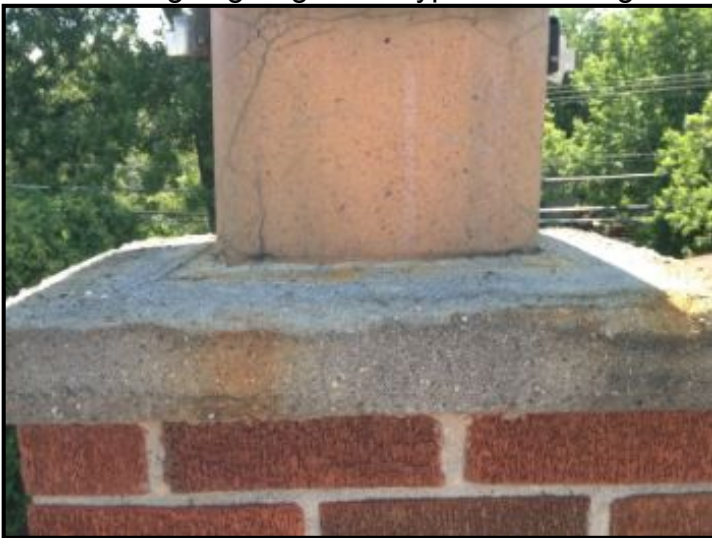
chimmney cap ok . monitor annually

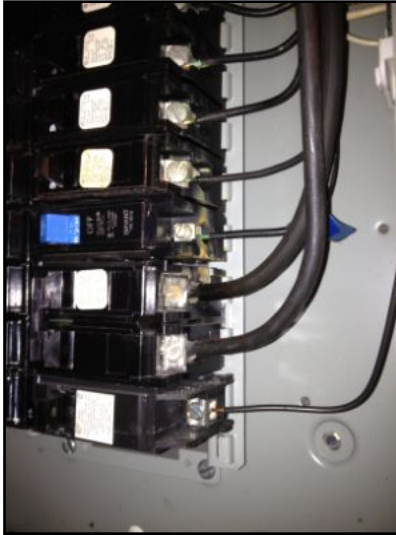
proper size aluminum service entrance cable
